St Bride's Church East Kilbride

Date : July 2015

Update Report

Main Church Urgent Brick Repairs and Associated Works

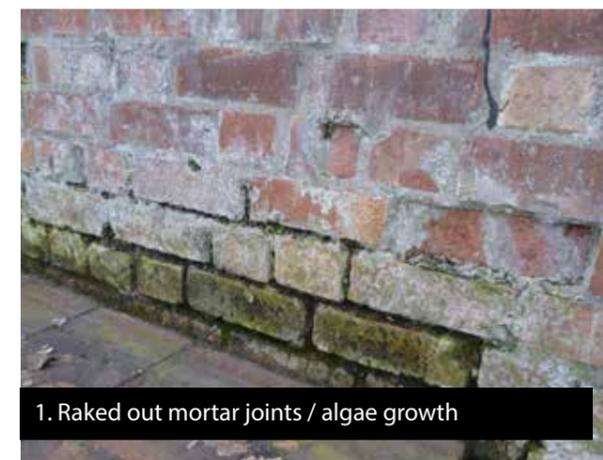
Due to the high altitude of the site, the effects of snow and precipitation can be seen in the washed out joints of all buildings at low level off the Piazza (1) and fungal growth where bricks have been constantly wet. This has also raised structural concerns on the implications for the Church roof which has a saw tooth profile and would allow snow to potentially sit on the roof for extended periods of time. There is also evidence of extensive brick spalling due to the exposed nature of the site (2).

1. Raked out mortar joints / algae growth

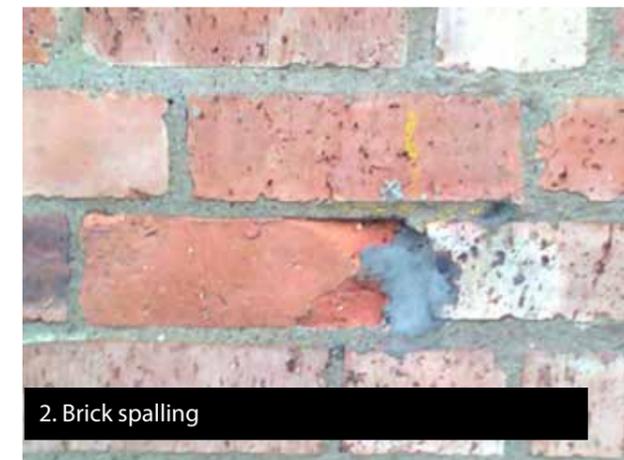
At the west entrance to the church, the mortar joints at low level have been washed out and there is evidence of severe weathering and brick spalling (1) above the level of the adjacent buildings.

2. Brick spalling

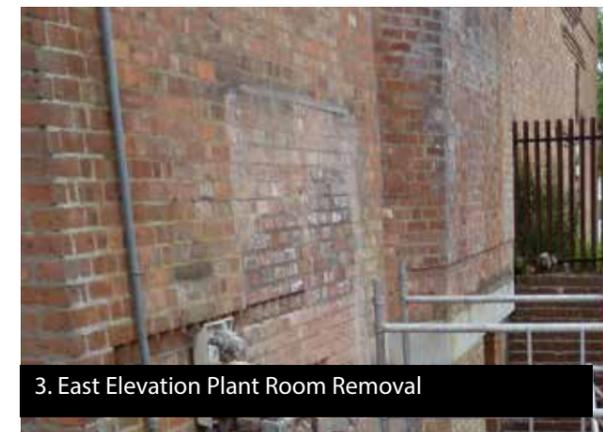
The east exit from the church was previously blocked off and a plant room built at the bottom of the steps to this door in the past. This plant area has now been removed and the door reinstated, however repairs will be required where the Plant Room was previously sited (3). The ground is also very wet to the east elevation at the french drain location running towards the north.

3. East Elevation Plant Room Removal

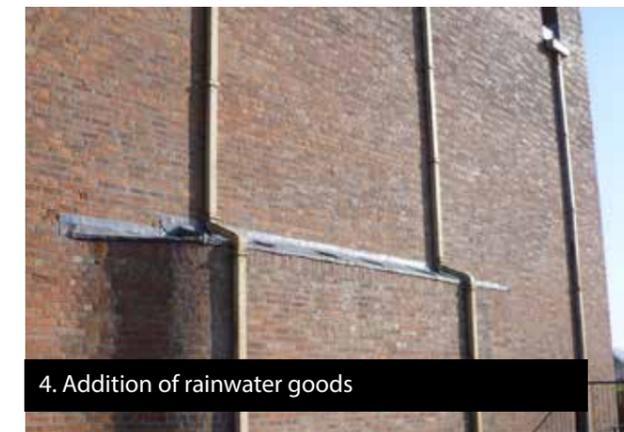
The north elevation has vertical patterns of cogging (6) to which lead cappings have been added, providing a richly textured surface. Rainwater goods have been added externally on both this and the south elevation ; most likely following issues with water ingress when these were originally in the cavity of the Counterfort Wall. The external downpipes have hoppers at the top just below the gutter line at the main roof gutters.

The connection between the roof outlets and the hopper will have to be investigated to establish if the connection is clear.

4. Addition of rainwater goods

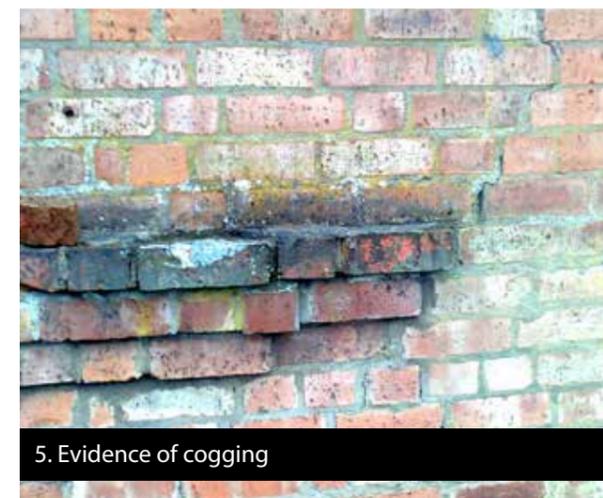
5. Evidence of cogging

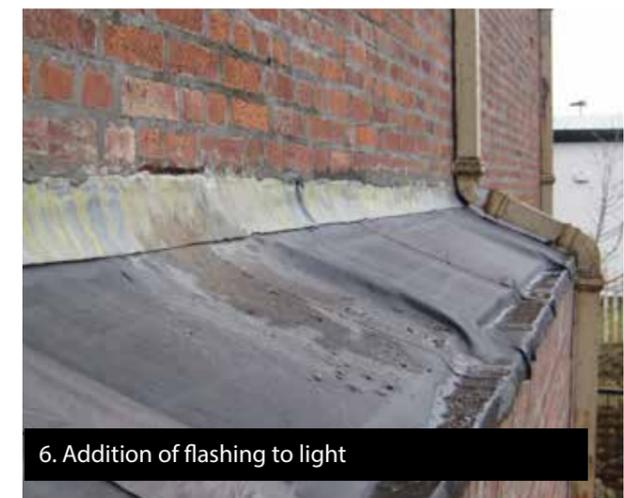
6. Addition of flashing to light

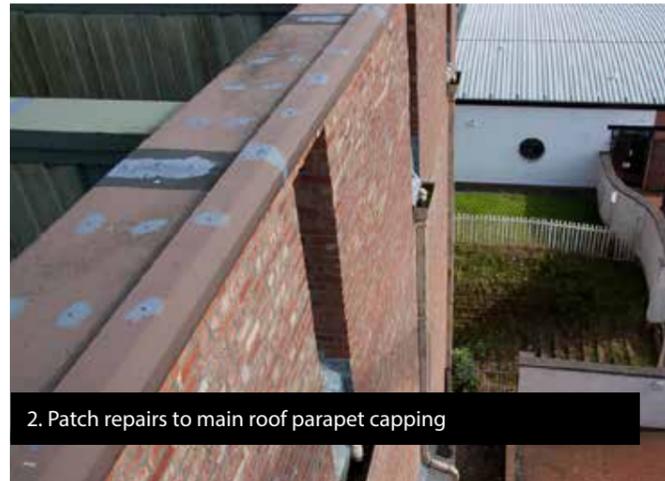
Flashings and repairs to the main roof parapet (2) have been carried out, with a metal profiled cladding now evident on the inside face.

2. Patch repairs to main roof parapet capping

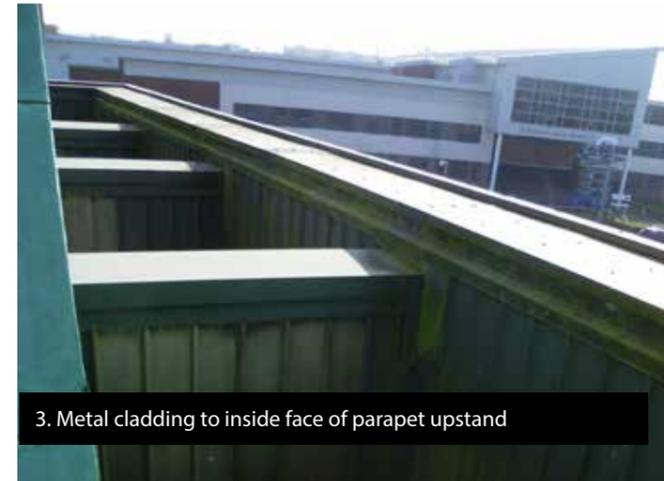
The angled roof sections have also been replaced and again a metal profiled cladding (3) is the current finish.

3. Metal cladding to inside face of parapet upstand

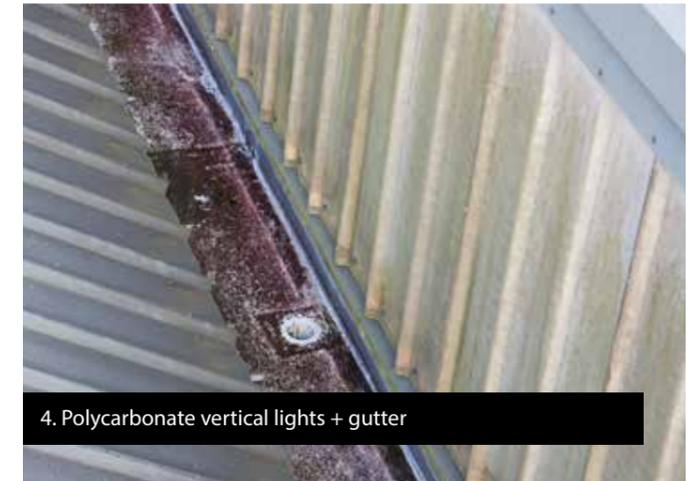
The vertical glazing, which was originally patent glazing has been replaced with a translucent polycarbonate, however the polycarbonate is now almost opaque and restricts light into the

Due to the sawtooth profile of the roof, it is difficult to access the roof to clear the gutters and some leaf guards are missing. This is a concern, particularly when there is snow on the roof which cannot be easily cleared (4).

4. Polycarbonate vertical lights + gutter

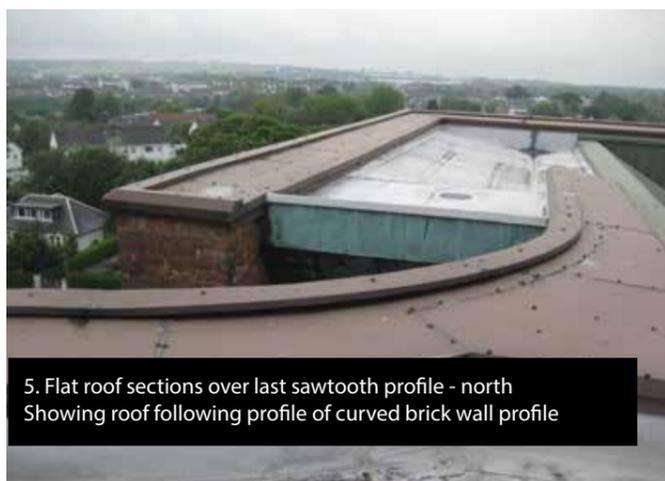
The original roof profile has been altered with raised flat roof sections where this would originally have been at gutter level. This is the area to the west of the last sawtooth ridge (5+6). This was to form a plantroom to the south west when the original underfloor heating system failed, however the new heating plant was ineffective and the area is now used for storage. A roof access hatch gives access to the flat roof areas and this is in fairly poor condition (6).

5. Flat roof sections over last sawtooth profile - north
Showing roof following profile of curved brick wall profile

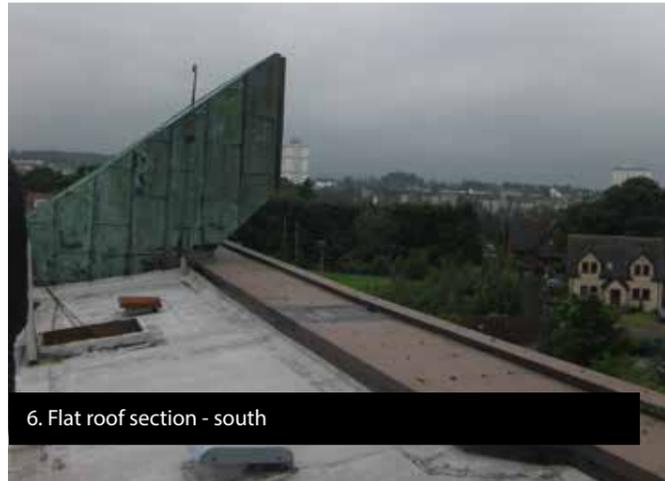
6. Flat roof section - south

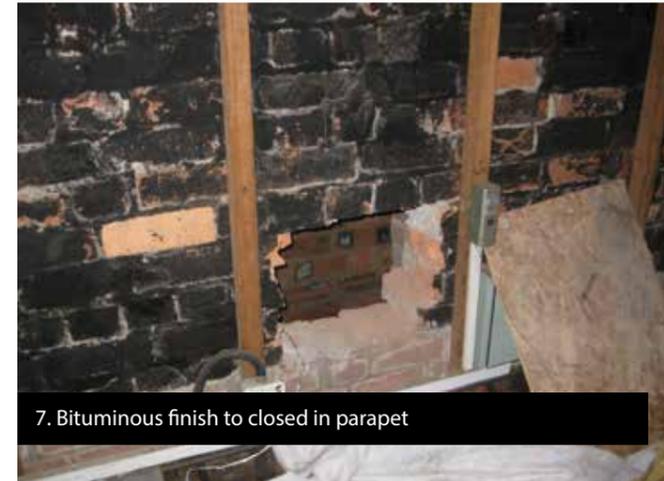
When the higher flat roof was installed, some time before 1988, the previously external brick parapet upstand became internal. This is coated with a black bituminous type paint (7), consistent with the original specification found in the Glasgow School of Art archive.

7. Bituminous finish to closed in parapet

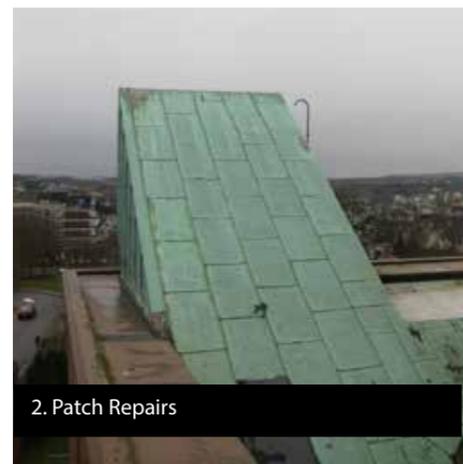
2. Patch Repairs

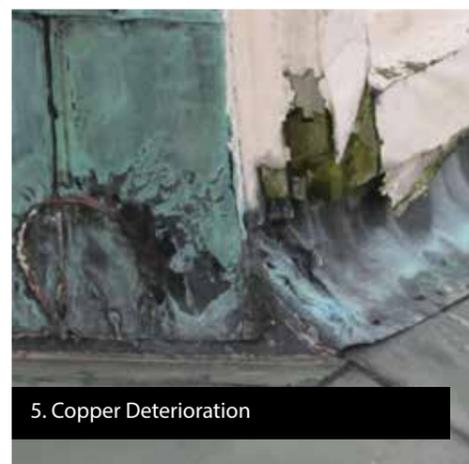
5. Copper Deterioration

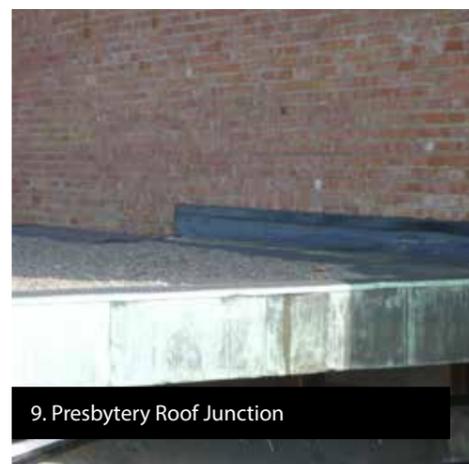
There is regular water ingress at the junction between the presbytery roof and the Main Church which is over the entrance off Plattthorn Drive (9). Repairs to the flashing have not been successful in stopping this water penetration.

9. Presbytery Roof Junction

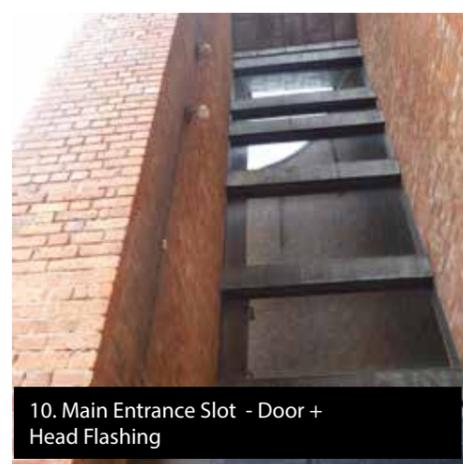
10. Main Entrance Slot - Door + Head Flashing

The main doors have a large apron flashing and while this area is fairly protected being within the west wall, this area is more exposed at the top and the flashings are not in good repair.

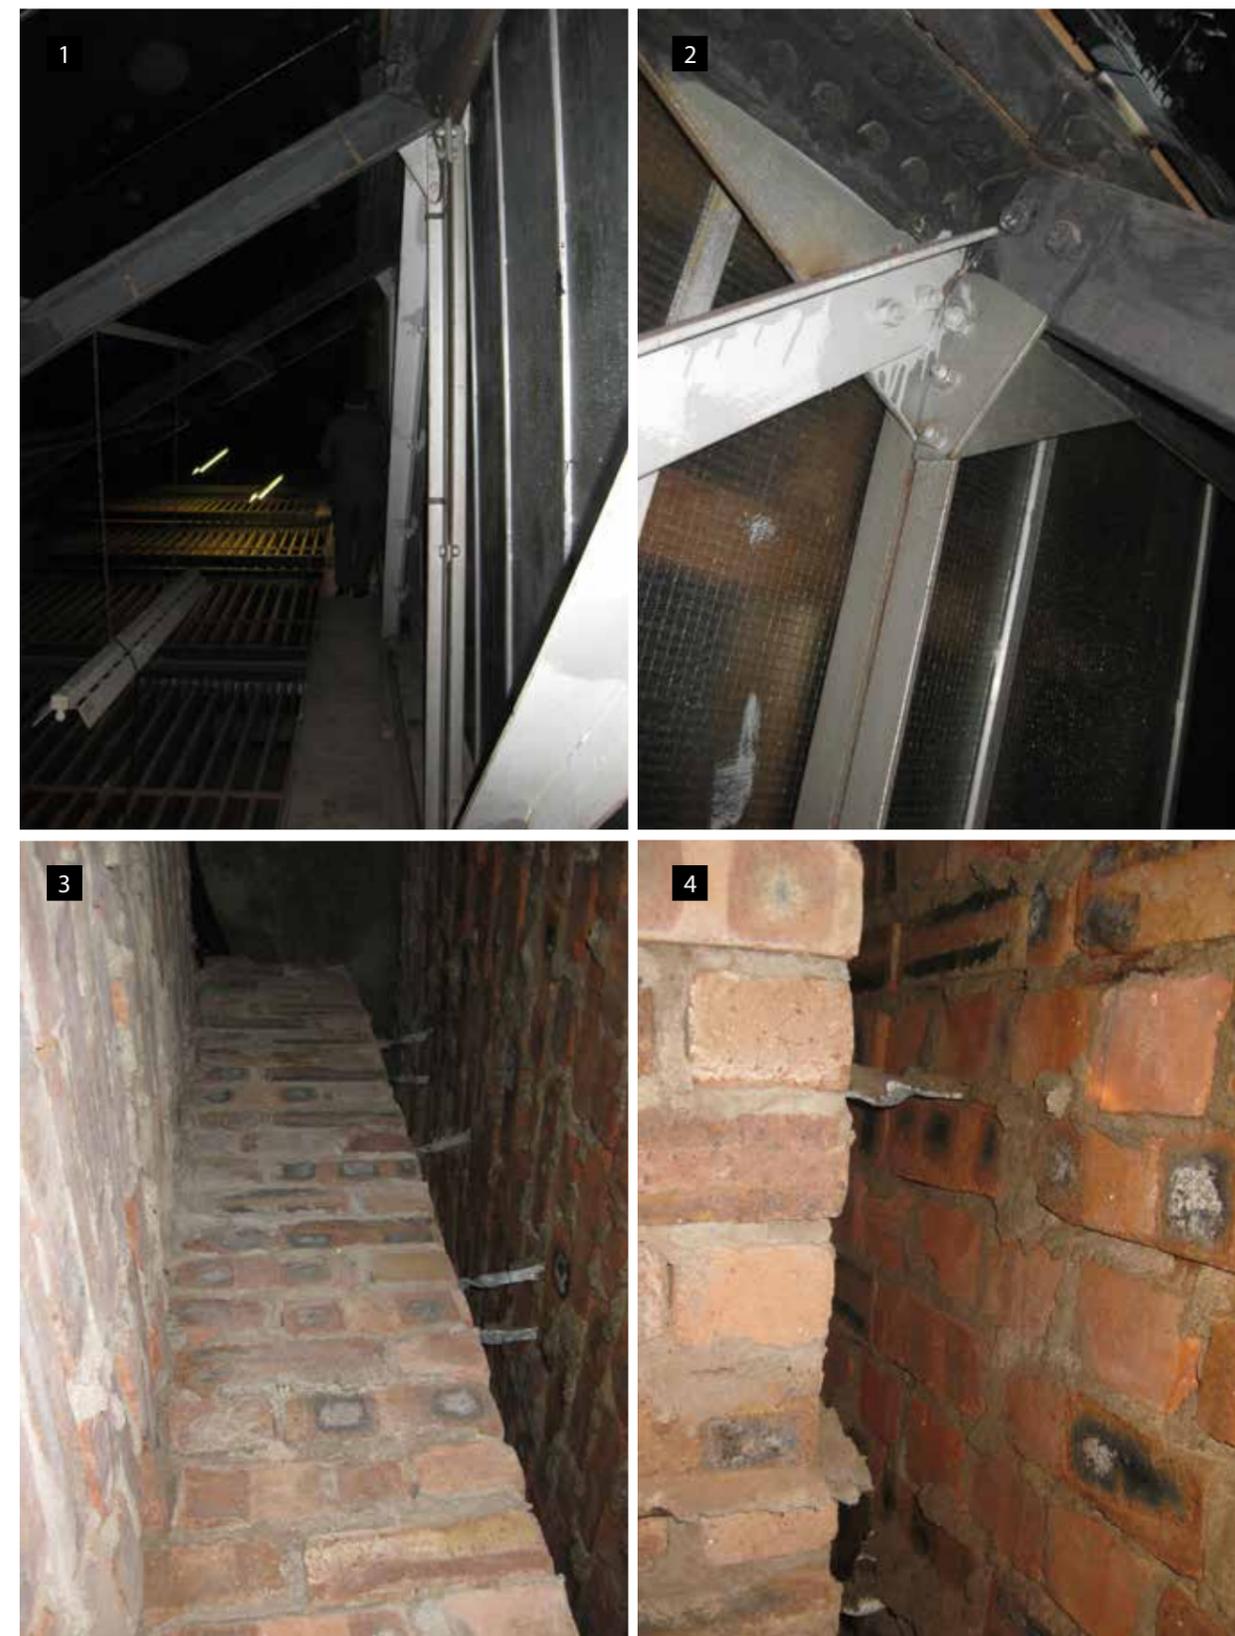
The original steel angle members forming the steel trusses do not appear to have any signs of fire protection or corrosion protection and corrosion was apparent in areas where there had been continual water ingress, particularly where truss ends met the external cavity walls.

1. Lightweight Roof Truss
 2. Roof Truss Connection Detail
 3. Vertical Cavity showing Twist Wall
 4. Mortar on Cavity Wall Ties

Based on this, Odin strongly recommended remedial wall tie insertion with stainless steel wall ties to ensure the walls continued to perform and ensure the leaves were tied together effectively.

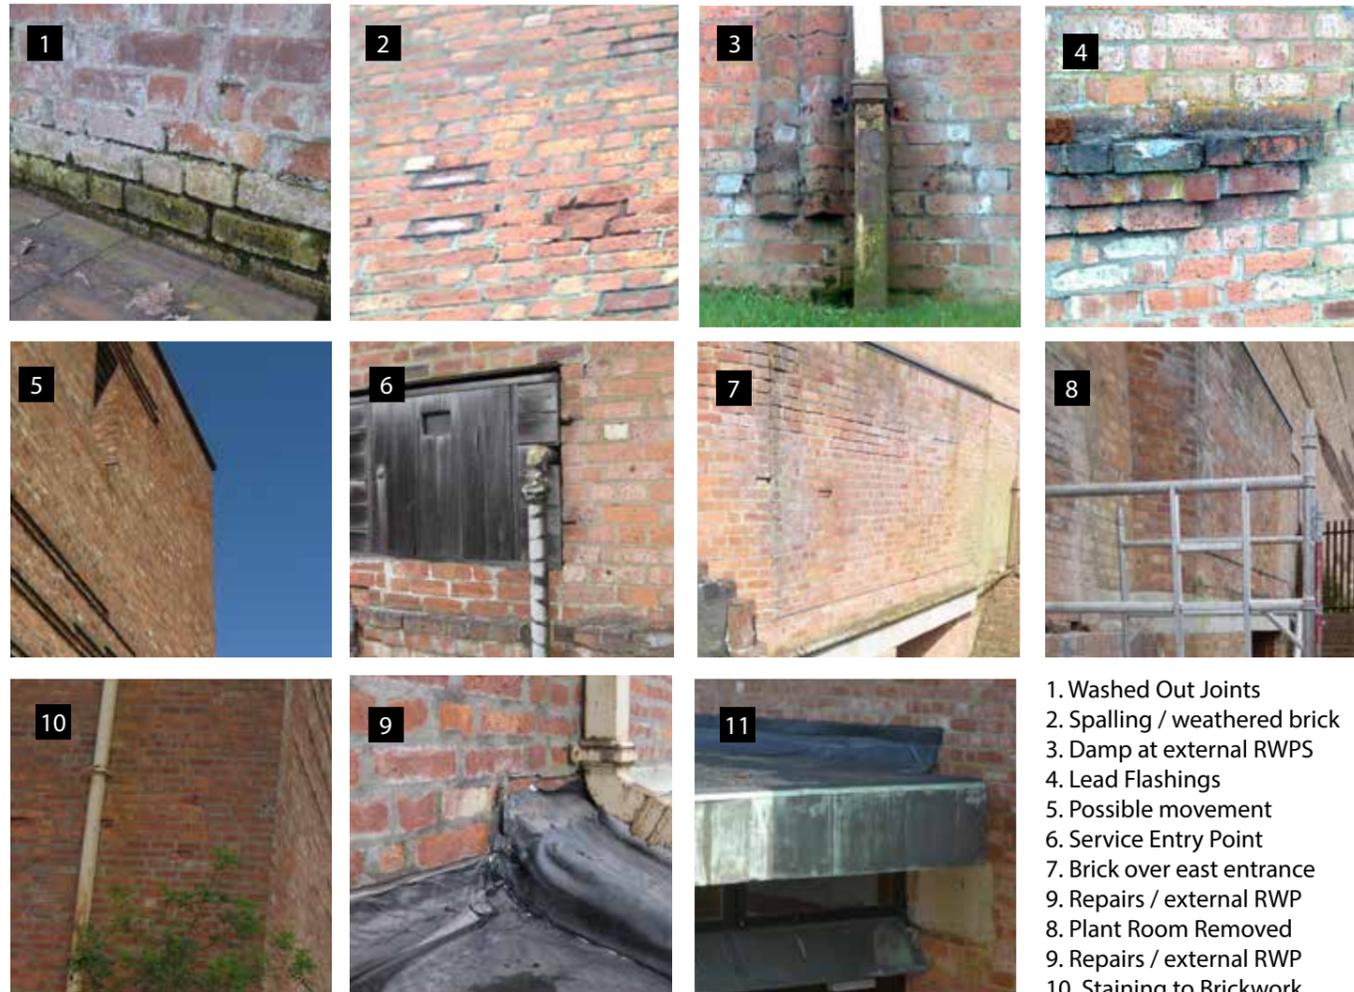
- Most significant weathering / spalling to the west elevation however brick repairs and repointing are required to all elevations.
- The main entrance slot is fairly protected, but the small flat roof and heavy flashing require replacement and there is staining visible at external light cabling
- Ongoing water ingress generally noted at junctions. Patch repairs and overflashings have not been effective and are unsightly.
- Significant ongoing water ingress to the South wall, particularly at the light over the altar has led to repairs being carried out to the main beam supporting the large cantilever concrete canopy inside. The beam depends wholly for its stability on the 'tight fit' between the beam and the mortar which is consistently wet.

- Rainwater downpipes have been moved from the cavity to external on the North and South Elevations at some point, probably due to water leakage issues. Rainwater goods in poor repair and damp / staining / water leaks are apparent. Investigation required of connection between roof gutters and hoppers.
- Possible movement at North East and South East corners
- Roof finishes taken over lights to chimneys in East Wall and at altar do not allow natural light penetration and leaks apparent. Original glazing replaced with polycarbonate and flashed over in some low level locations. Some original georgian wired vertical lights remain in roofed over area at high level.
- The north elevation is in the best condition
- The DPC/DPM does not seem to be continuous and requires further investigation

1. Washed Out Joints
 2. Spalling / weathered brick
 3. Damp at external RWPS
 4. Lead Flashings
 5. Possible movement
 6. Service Entry Point
 7. Brick over east entrance
 9. Repairs / external RWP
 8. Plant Room Removed
 9. Repairs / external RWP
 10. Staining to Brickwork
 11. Presbytery Roof Junction

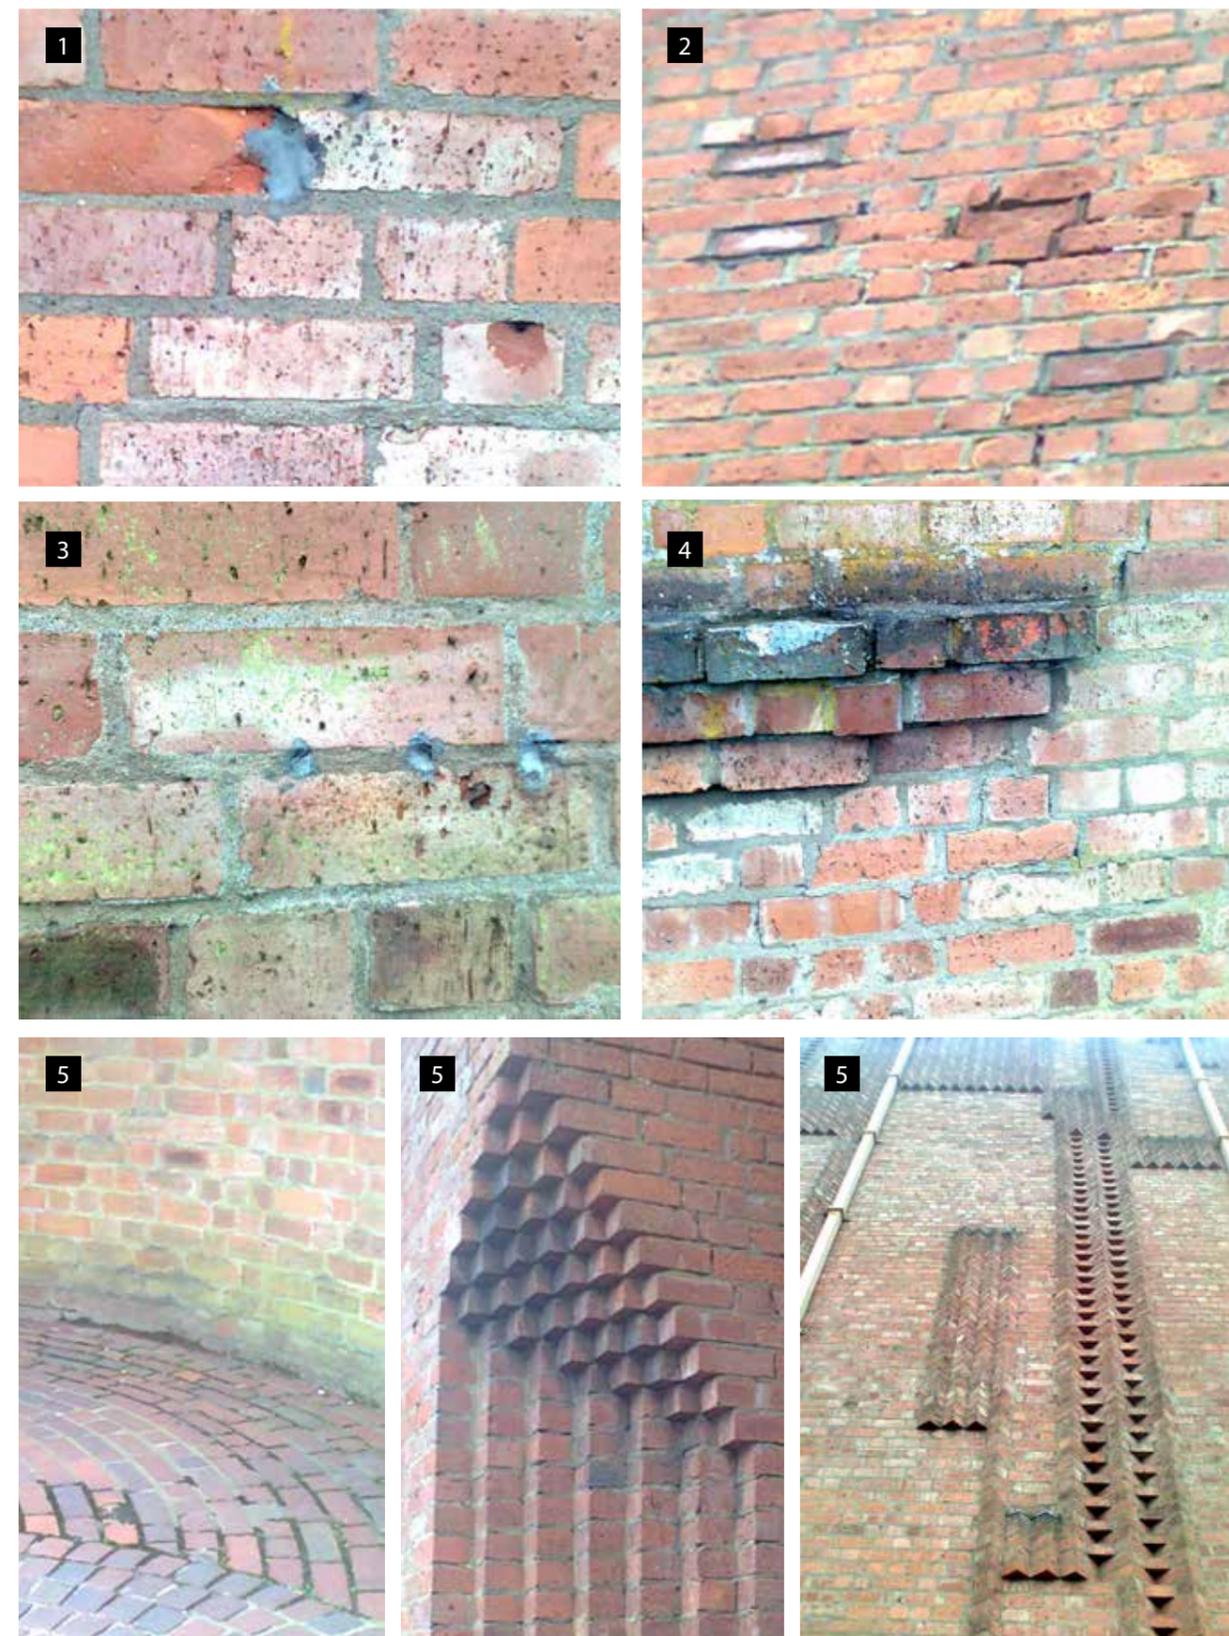
The brickwork, important to the character of St Bride's, would be a case of like-for-like repair or replacement. The surface of the brick is spalling (1) and the decay is most noticeable in the south and west elevations of the church (2), where the building is most exposed to the prevailing weather. The north elevation, prominent over Whitemoss Road, is the best preserved.

Weathering details - The projecting brick details, or cogging (4), on the church walls appear to have been originally topped on the horizontal surface with a tapered mortar bed, as a method of weathering. Fragments are still extant on the east elevation. The details on the north elevation have been capped in lead. The principal should be in favour of retaining cappings which are performing well and reinstating the original detail where it has been lost.

- 1. Example of 'Spalling'
- 2. South Elevation - brick replacement required
- 3. Example of Structural Testing
- 4. Example of 'Cogging'
- 5. Example of intricate brick detailing visible throughout

The wall heads, originally exposed brick, had the top two courses removed in 1988 and were then capped in a metal sheet. The exposure is too great to return to the original detail, so a discrete capping detail in a suitable traditional material (copper or lead) should be considered.
