St Bride's Church East Kilbride

Date : July 2015

Update Report

Main Church Urgent Brick Repairs and Associated Works

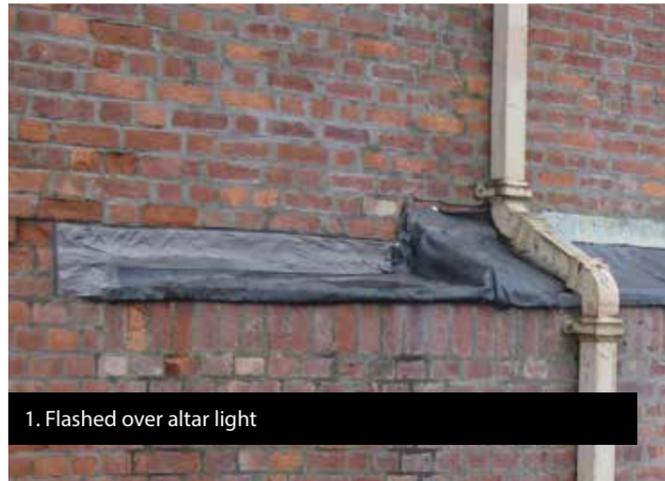
1. Flashed over altar light

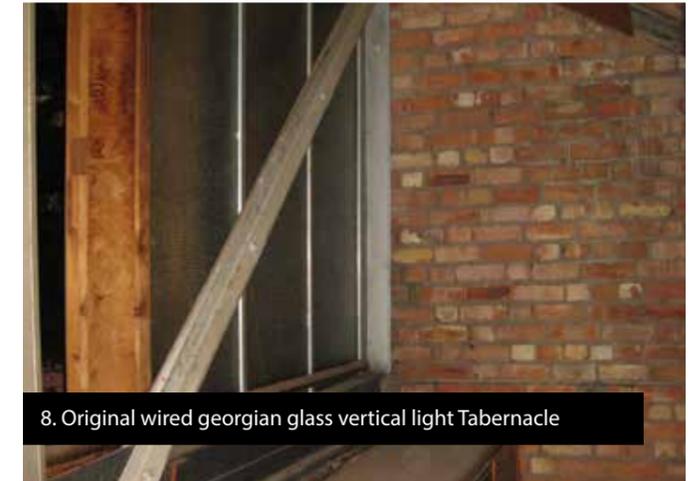
8. Original wired georgian glass vertical light Tabernacle

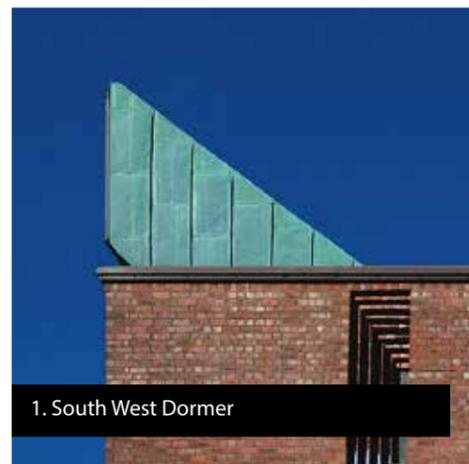
1. South West Dormer

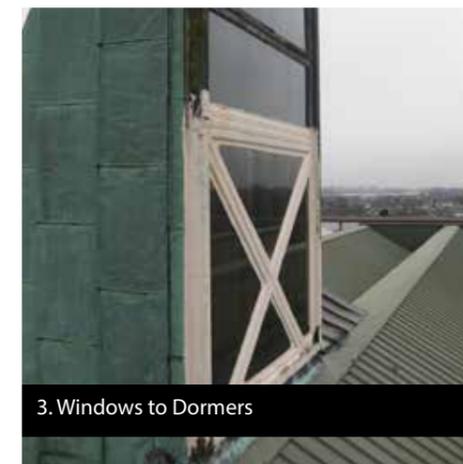
3. Windows to Dormers

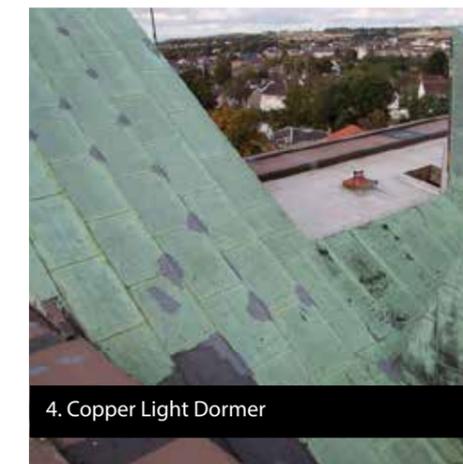
4. Copper Light Dormer

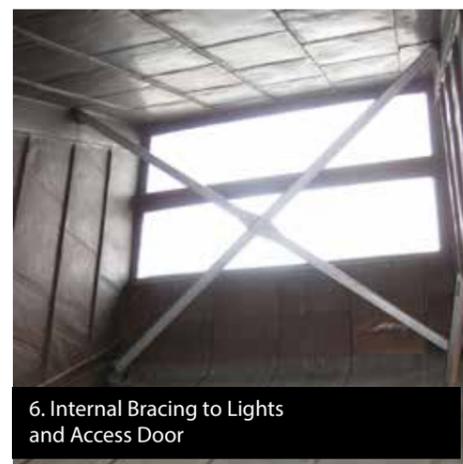
Three tall dormers provide additional natural light to the High Altar and Lady Church areas. These have a steel frame with timber framing above and below and are copper clad internally and externally. The copper is green patinated externally and dark brown internally (1-6). The dormers are very exposed as they project above the roof line. The timber vertical lights externally are in very poor repair requiring the integrity to be checked, and the copper cladding externally shows signs of deterioration with open joints allowing water ingress. There have been patch repairs, however there is evidence of continued water ingress through these elements. Internally, access across the voids below the lights, to a small door leading to an area to the south west, is via a very narrow walkway with no edge protection (6).

6. Internal Bracing to Lights and Access Door

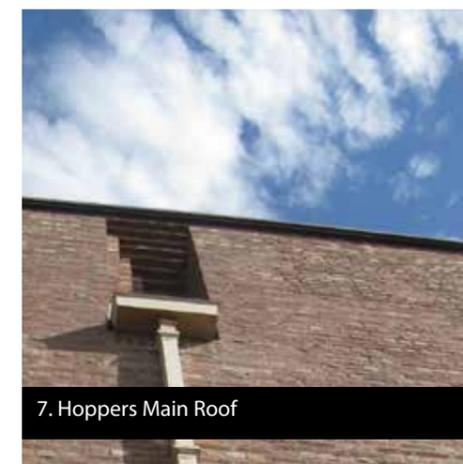
7. Hoppers Main Roof

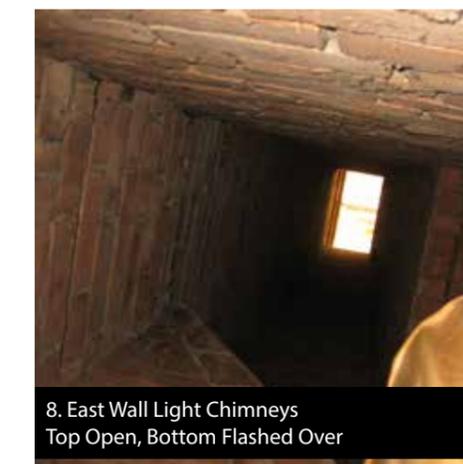
8. East Wall Light Chimneys Top Open, Bottom Flashed Over

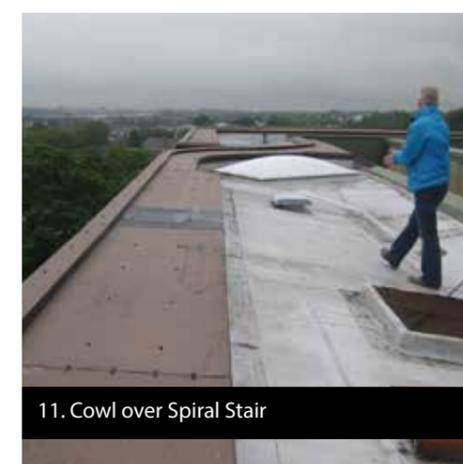
11. Cowl over Spiral Stair

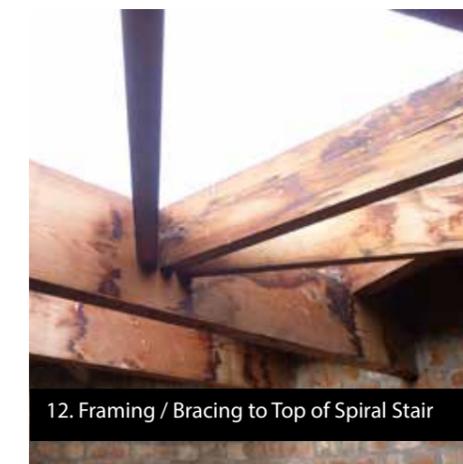
12. Framing / Bracing to Top of Spiral Stair
